## Lagoon Dewatering Solutions Case Study: The Municipality of Arran-Elderslie

The Municipality of Arran-Elderslie operates three sewage lagoons, located in the town of Chesley, Ontario. In 2009, the Municipality sought a solution for cleaning up the newest of the towns three lagoons, for the first time in it's twenty five year history.

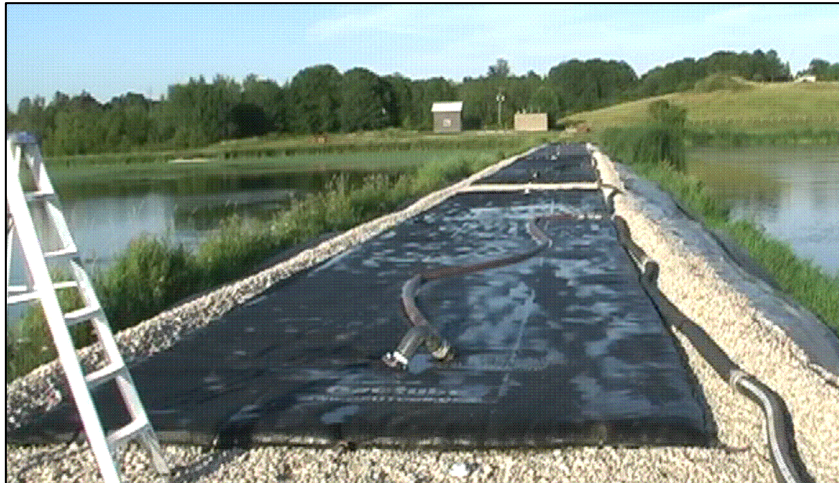
*In August 2009, Six Geotube<sup>®</sup> units were used to dewater and contain sludge pumped from one of the three sewage lagoons operated by The Municipality of Arran-Elderslie.*

A temporary dewatering cell consisting of a geo-membrane and crushed stone was constructed along the edge of the lagoon. The dewatering cell was constructed to allow clear filtrate dispersing from the tubes to be directed via gravity back into the lagoon. Six Geotube<sup>®</sup> units measuring thirty feet in circumference by one hundred feet in length were brought on site to dewater and contain the lagoon sludge.

A dredge was used to blend the sludge in the lagoon, and transfer it to the Geotube<sup>®</sup> units. Sludge was

pumped through a mobile PVC mixing chamber where it was injected inline with polymer. The injection of polymer creates a flocculation in the sludge, causing the solids to bind together and separate from the liquid.
